Water level and subsidence recovery from managed recharge

Thomas J. Burbey
July 2, 2019

Workshop for Land Subsidence Prevention and Mitigation

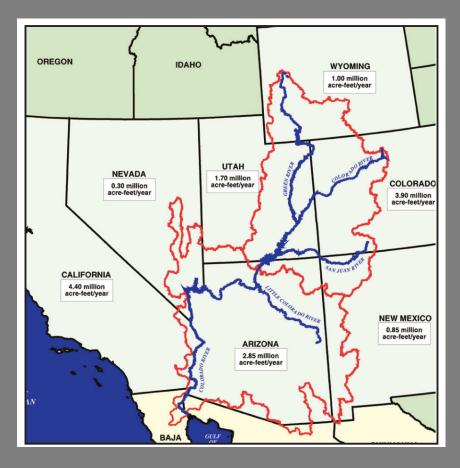
Colorado River Allocations

In 1922 the Colorado
River Compact defined
the allocations for the
Colorado River for each
geographic region.
Nevada was allocated
300,000 ac-ft/yr.
The Hoover Dam was
later built and completed
in 1936 creating Lake
Mead

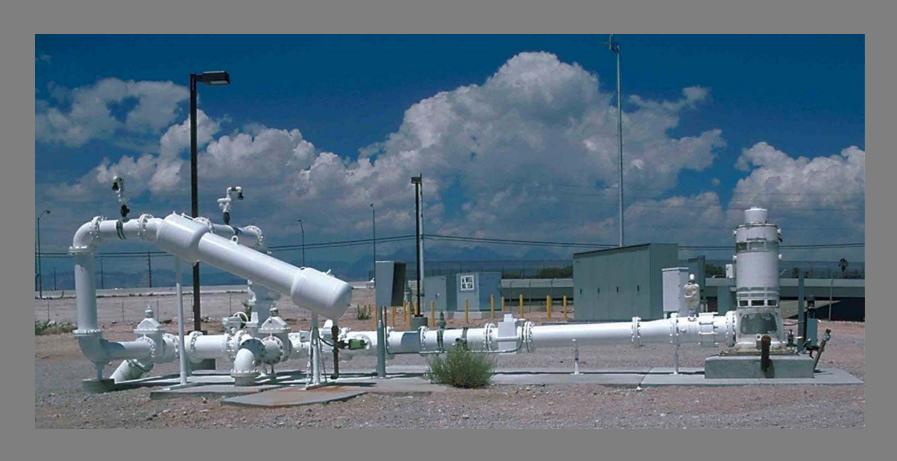
Artificial Recharge

A number of wells that are used for pumping during the summer are used to artificially inject water back into the aquifer during the winter months

To help mitigate the ongoing occurrence of land subsidence, an artificial recharge program was initiated in 1988. This program resulted in a as much as 30 m of groundwater level increase between 1990 and 2005

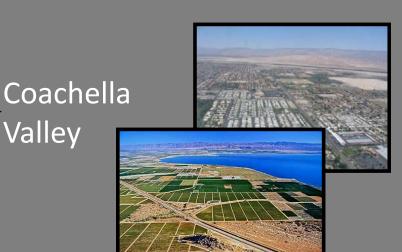
Coachella Valley Groundwater Subbasins

- Groundwater subbasins defined by
 - Groundwater levels
 - Groundwater chemistry
 - Geologic structure

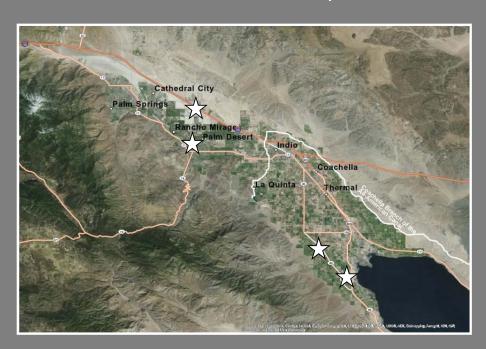
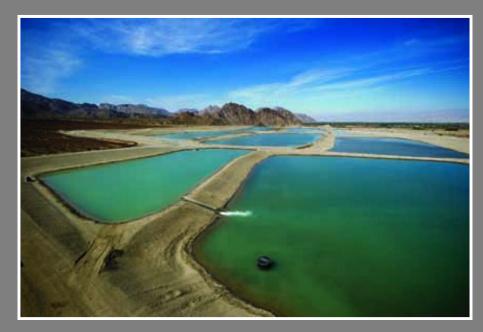
Percolation Ponds

- Whitewater River since 1973 (SWP)
- Mission Creek (near Desert Hot Springs) since 2002 (SWP)
- Martinez Canyon since 2007 (Colorado River)
- Thomas E. Levy Groundwater Replenishment Facility since October 2009 (Colorado River)

- Periods of groundwater-level declines since the 1930s have caused land subsidence in the Coachella Valley
- Groundwater levels in many parts of the valley have stabilized or risen during the last decade
 - Largely associated with managed recharge using percolation ponds
- The stable or rising water levels have resulted in slowed or stopped subsidence
